X-Protect

Double impact low

AXELENT AB
WWW.AXELENT.COM

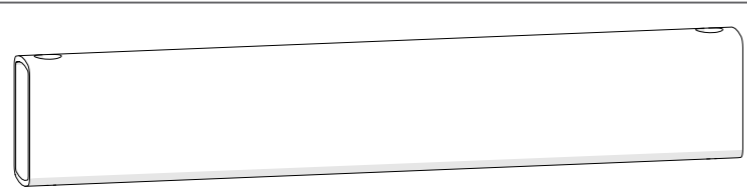
RCI1-XXX-XXXX
 ECI1-length-centre to centre)

The pin hole location, size and adjacent material integrity are critical to the overall system function and performance. Axelent therefore advises against any onsite alterations as performance cannot be guaranteed.
