# X-Protect

Pedestrian

**AXELENT AB**

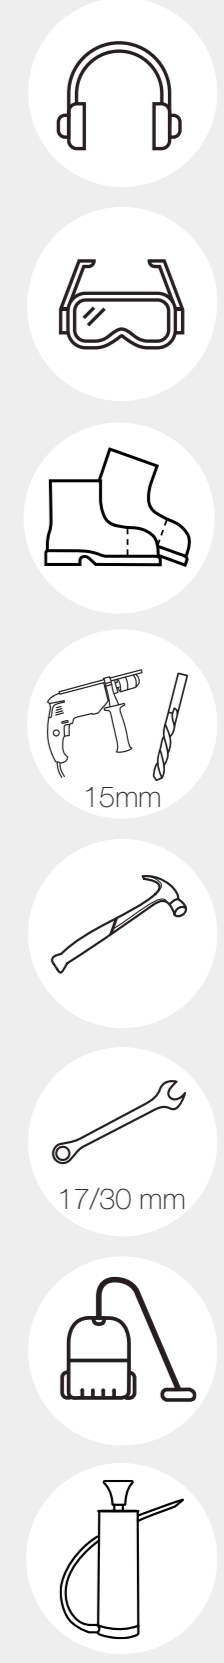
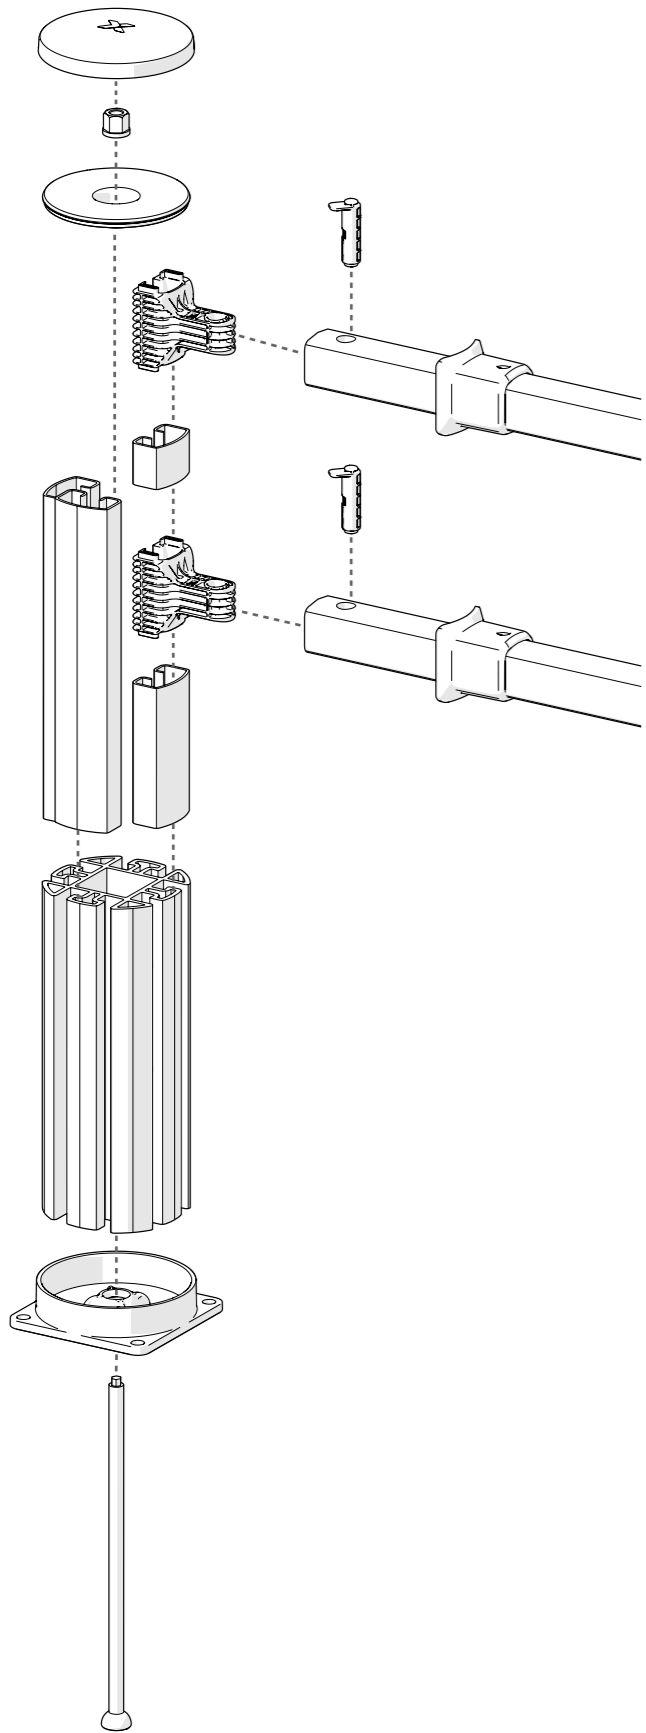
**RCP1-XXX-XXXX**  
 (RCP1-length-centre to centre)

*The pin hole location, size and adjacent material integrity are critical to the overall system function and performance. Axelent therefore advises against any onsite alterations as performance cannot be guaranteed.*
